NATIONAL TRANSPORTATION SAFETY BOARD

RAILROAD ACCIDENT REPORT

DERAILMENT OF RINGLING BROS. AND
BARNUM & BAILEY CIRCUS BLUE TRAIN
NEAR LAKELAND, FLORIDA
JANUARY 13, 1994

Adopted: February 14, 1995
Notation 6321A

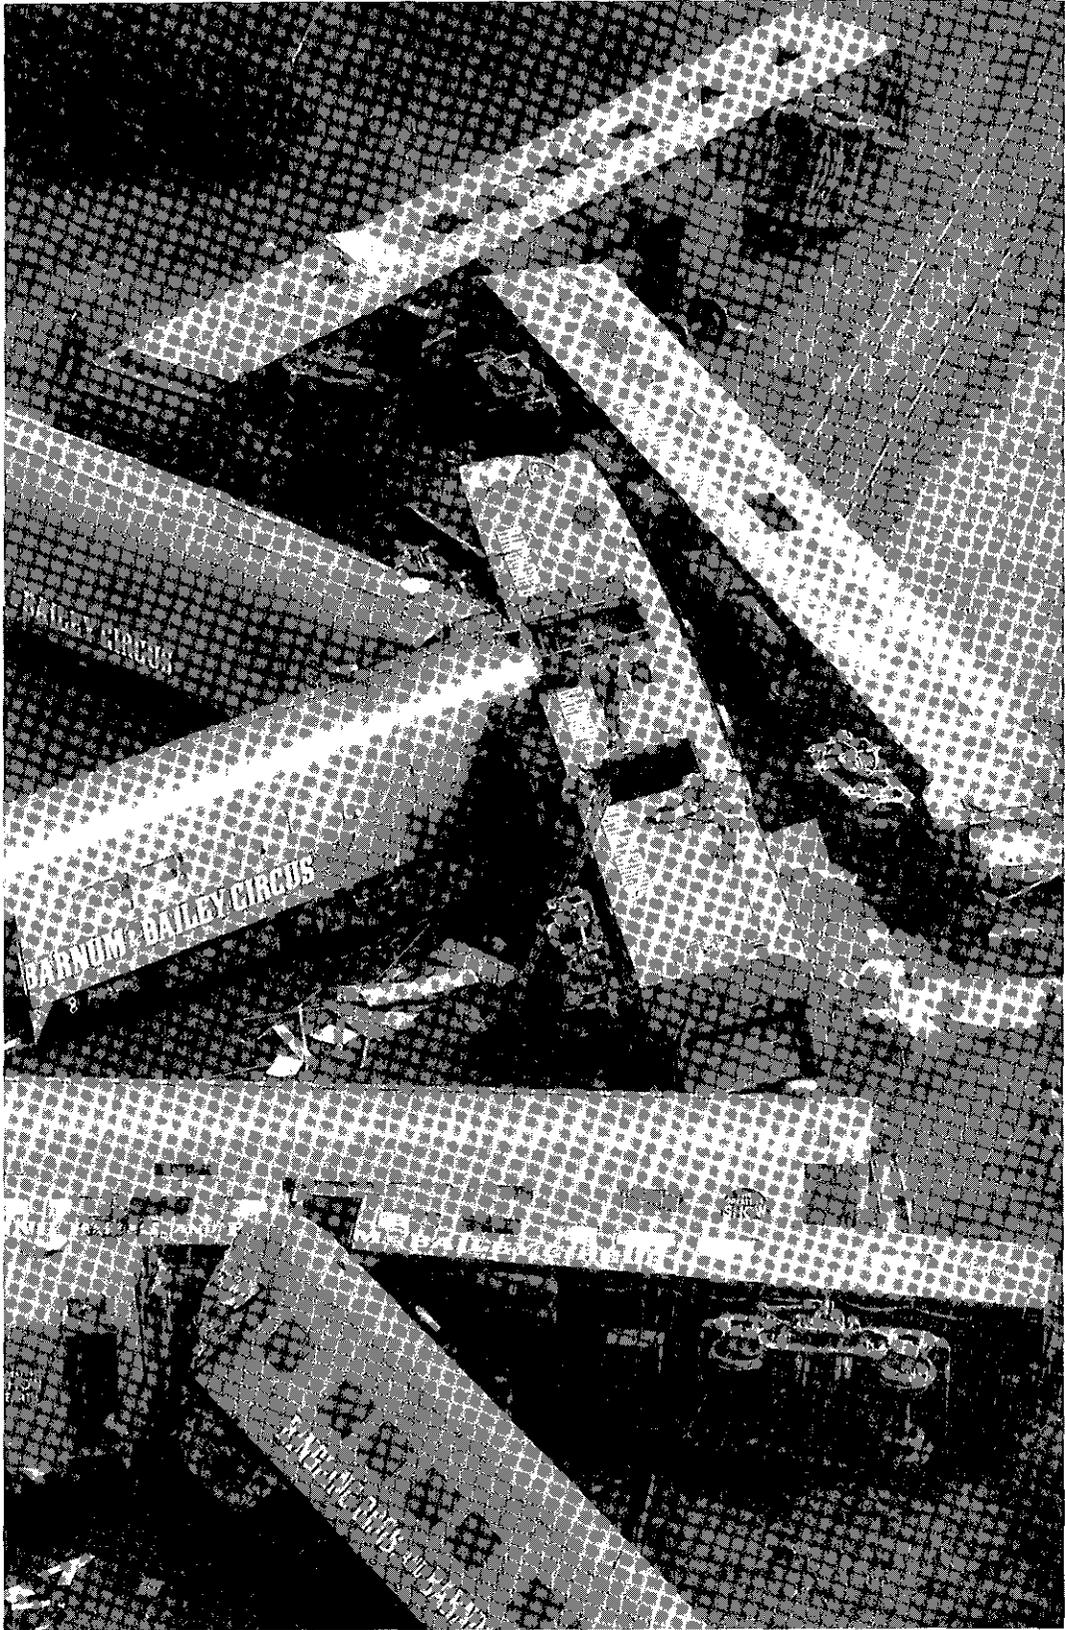
Figure 3.--Photograph of cars on their sides

The train continued 2.7 miles across five grade crossings¹⁴ with the broken wheel and derailed truck of car 89. At MP 847, 15 cars derailed (the general derailment) at the Park Spur turnout,¹⁵ starting with the 22nd car, car 88 (see figure 2). Of the 16 derailed cars, five fell on their sides, the rest remained upright (see figures 3 and 4).

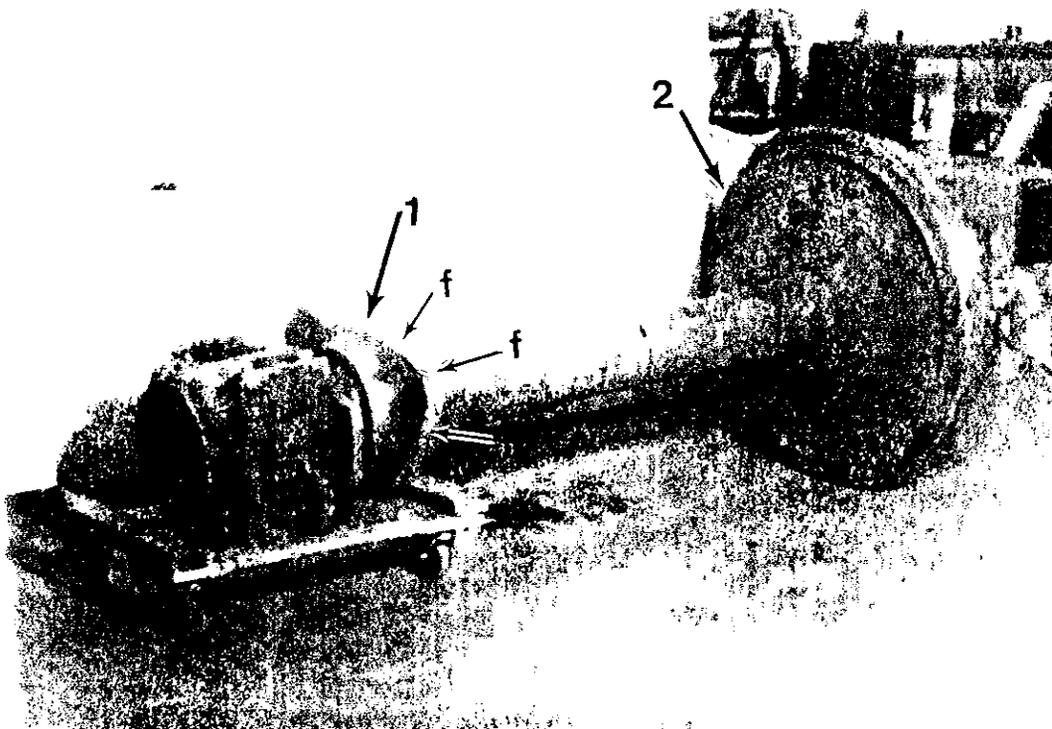
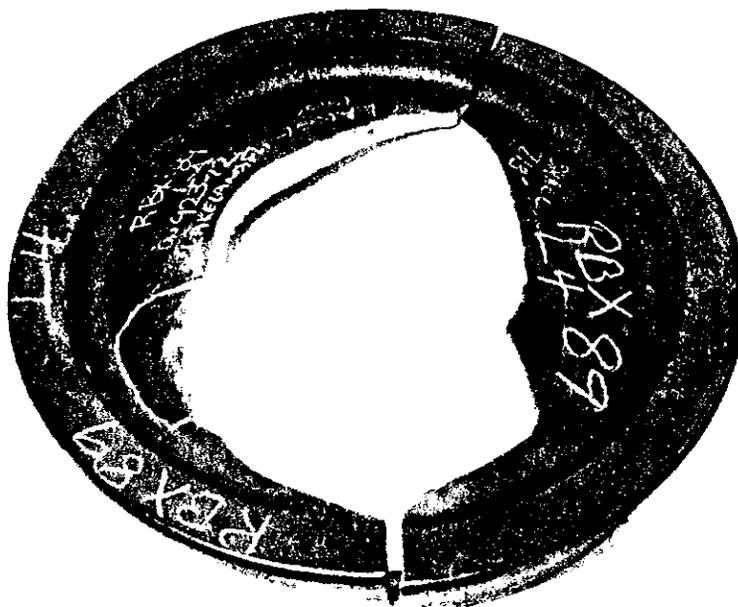
Wheel --The L-4 wheel on car 89 had broken into three pieces; one piece had remained attached to the axle. After the derailment, the two broken-off pieces from the wheel were recovered and taken along with the hub part of the wheel set to the local CSXT car shop for a preliminary inspection. The broken wheel and the mate wheel showed no signs of discoloration²³ on the wheel plates or on the tread. During initial examination, investigators noted the presence of what appeared to be "oyster shell" markings²⁴ on the fracture surface of the wheel where the

Figure 1 Overall view of the submitted components. Arrows "1" and "2" in the top photograph denote the separated and intact wheels, respectively. The broken off pieces of the wheel are shown in the bottom photograph.

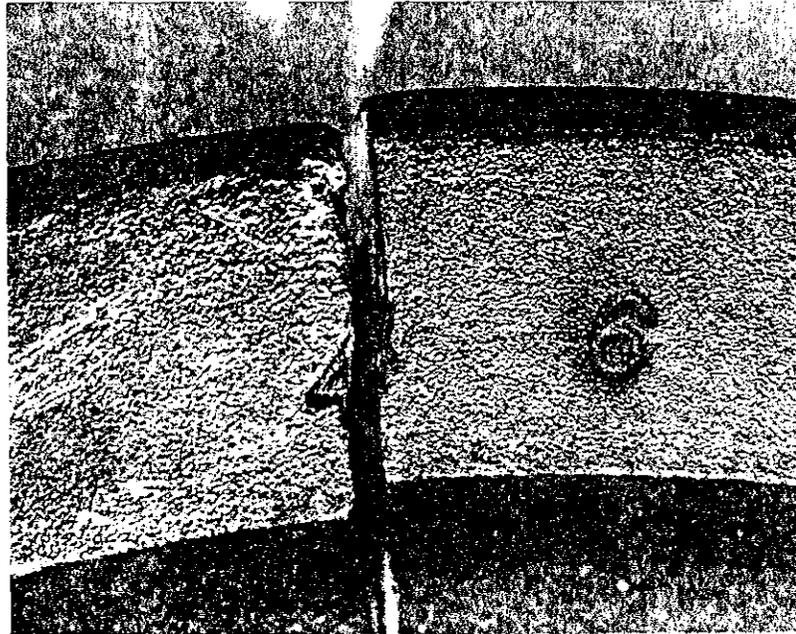
wheel had broken below the deeply stamped 4 of the serial number on the back (inside) of the rim, along the vertical straight line of the number. The oyster-shell pattern is typical of a progressive failure from a fatigue crack.

Figure 2 Close up view of the portion of the rim showing the separation through the long leg of the stamped number "4"

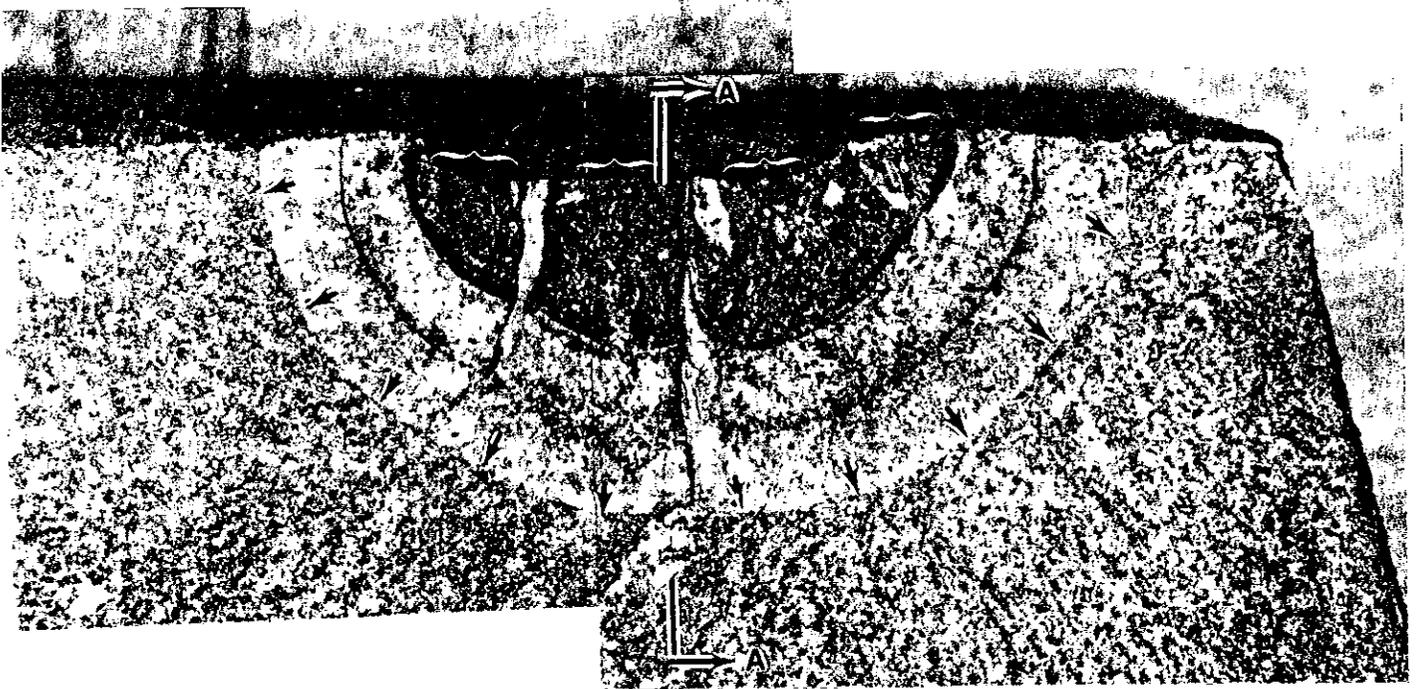
A Safety Board materials laboratory examination of the fractured accident wheel disclosed that the wheel separation stemmed from a fatigue crack approximately 1.35 inches wide by 0.55

inch deep. This fatigue crack initiated from multiple origins at the base of the serial number character 4 that was stamped on the gage-side face of the rim. Although the mate wheel was not fractured, it also had a hairline crack that was approximately 0.6 inch long, that was located mainly along the bottom of the long leg of the 4. Sectioning through the mate-wheel crack indicated it was about 0.12 inch deep and was filled with high-temperature oxides.

Figure 5 Close up view of the of the fatigue fracture zone Brackets indicate some of the fatigue origin areas Extent of the fatigue cracking is denoted by the arrowheads Location of the metallographic specimen is shown by the sectional arrows "A-A" Magnification 3.5X

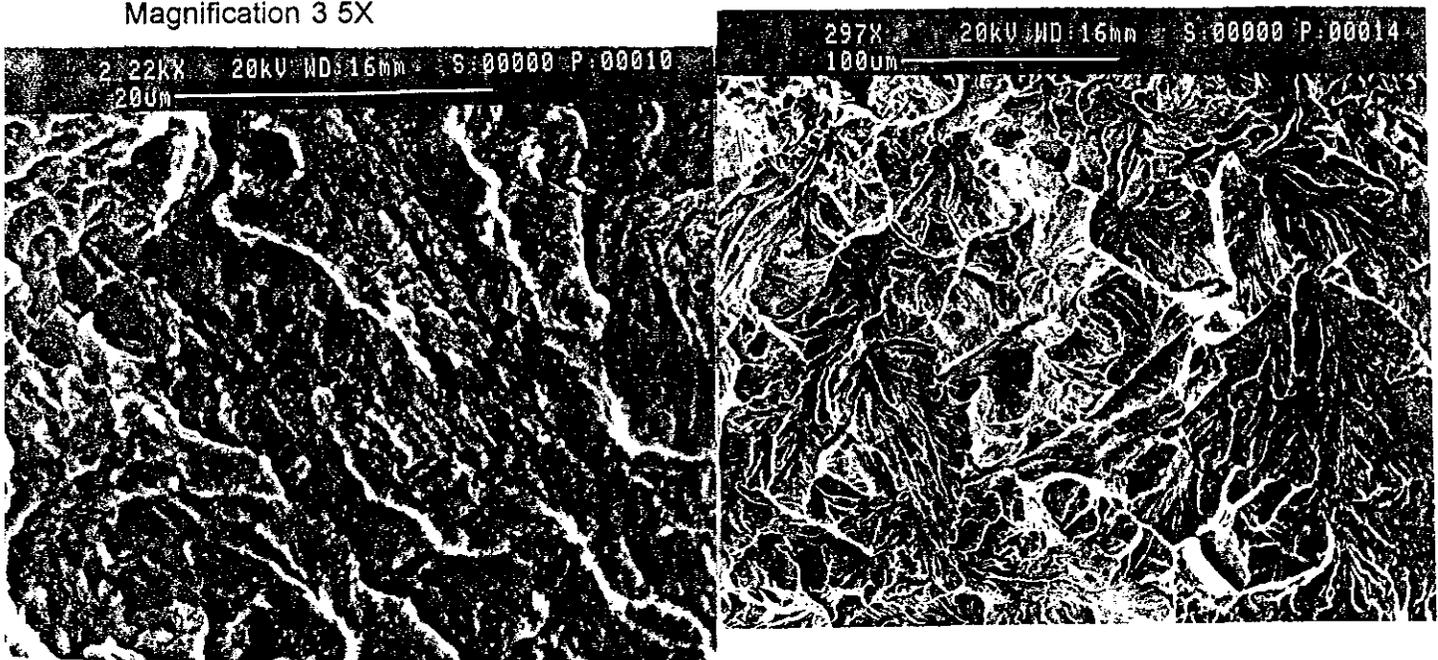
Figure 6. Typical micro-features in the fatigue (left fractograph) and overstress (right fractograph) fracture zones Magnifications left - 2,220X, right - 297X

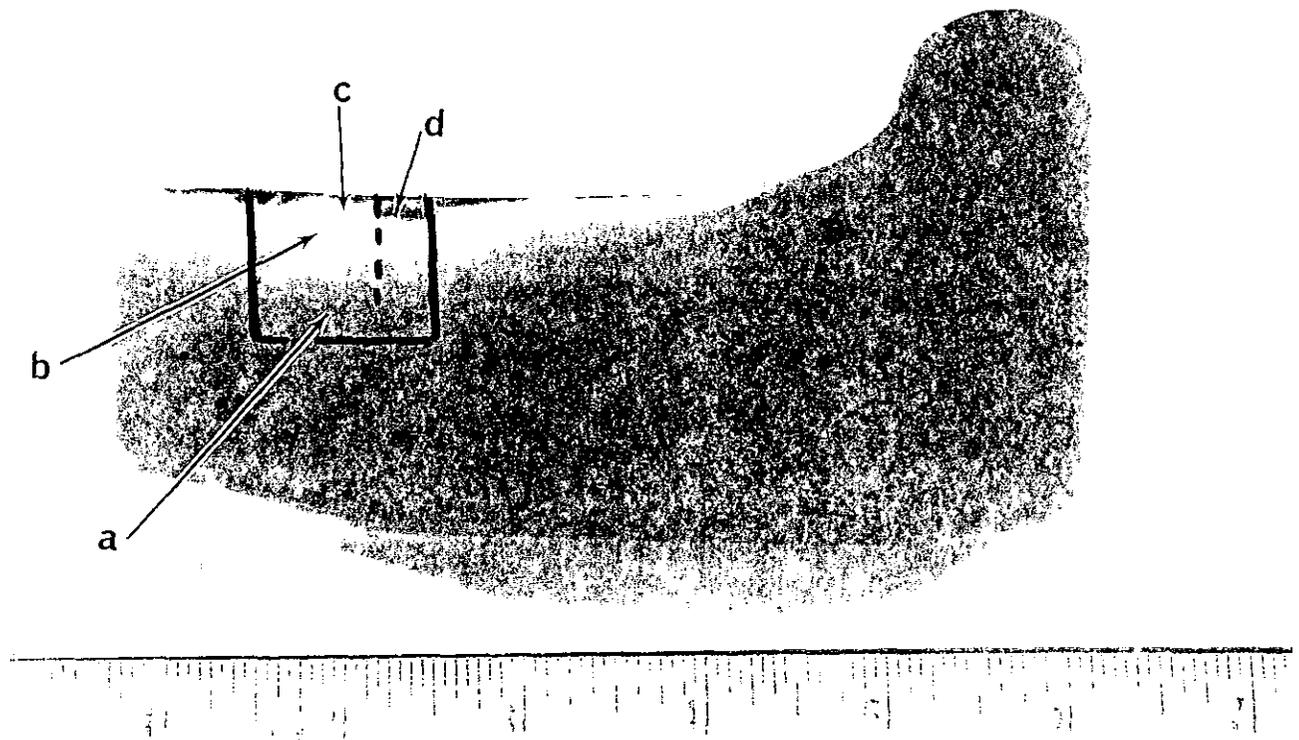
Figure 7 Photomicrograph of the polished and etched section of the rim showing four distinct microstructural zones below the tread surface

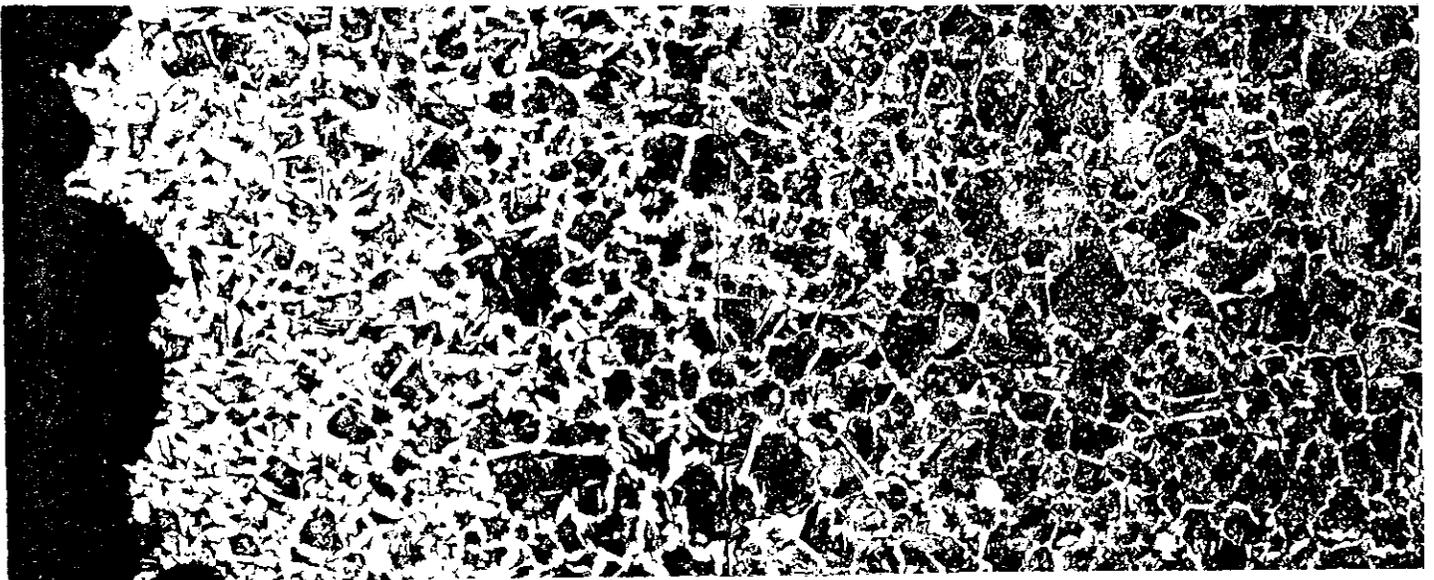
Figure 10 Composite photomicrograph showing the microstructure of the wheel material underlying the stamp at the location shown by the dashed line in figure 9 Etch - 2% Nital, magnification - 200X
